ALWAYS FIRST
HOME INSPECTIONS
INTERNACHI CERTIFIED

Home Inspection Report

1234 Main, Syracuse , UT 84075

Friday November 24, 2017

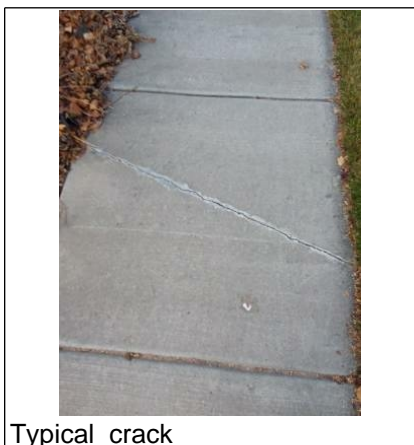
Comments Walkway had some cracking, but is usable. Recommend sealing crack.

Typical crack

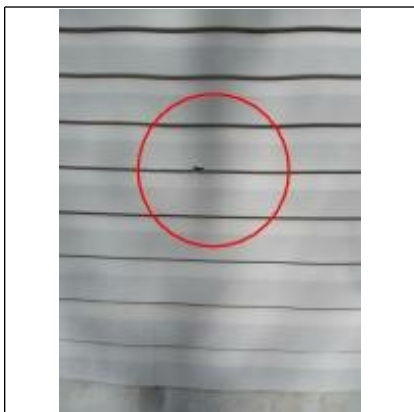
Comments Siding appeared to be all intact and in overall satisfactory condition.
Small hole on sliding. Recommend repair.
Cracks in stucco siding/ exposed concrete, recommend repair.

Hole in sliding.

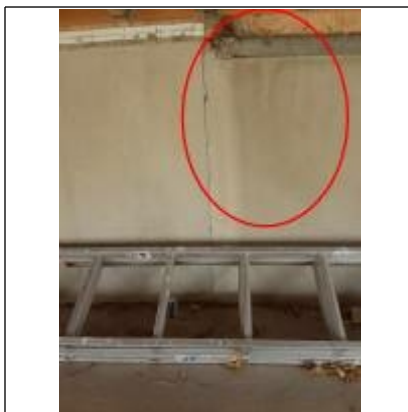
Crack and exposed concrete

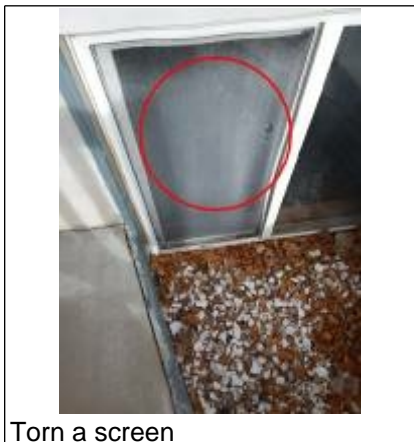
Comments Some screens not installed.
 Some screens are torn recommend repair

Torn a screen

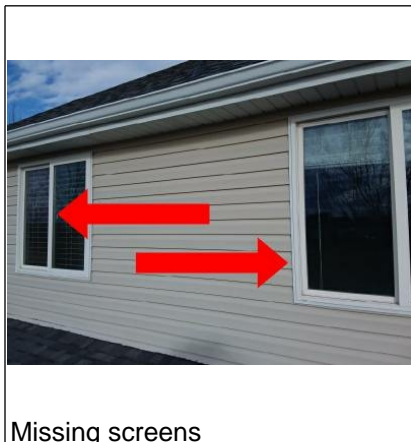
Missing screens

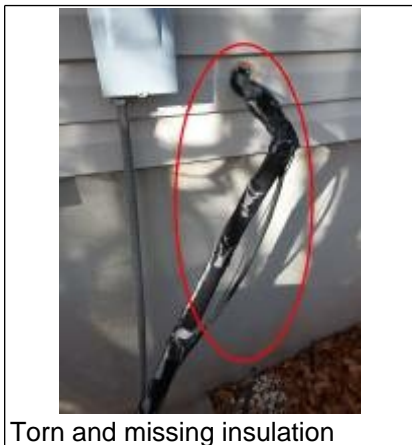
Torn and missing insulation

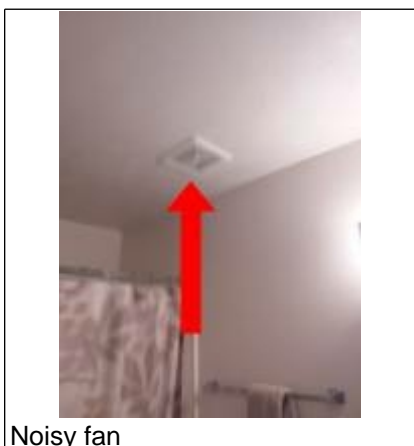
Comments Exhaust fan noisy.

Noisy fan

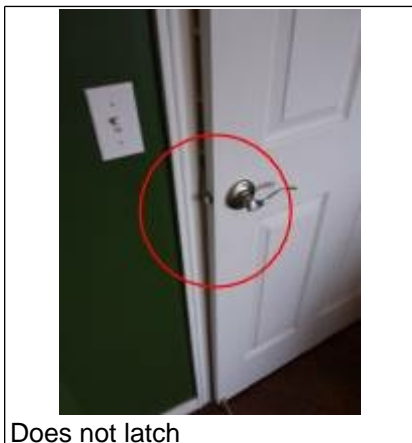
Does not latch

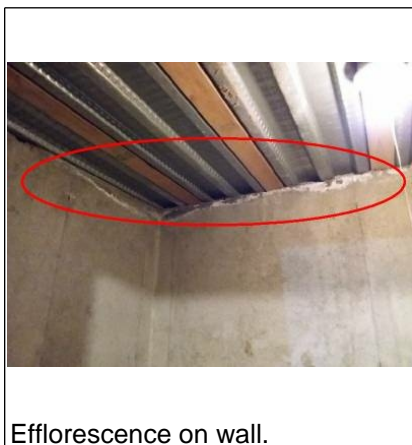
Efflorescence on wall.

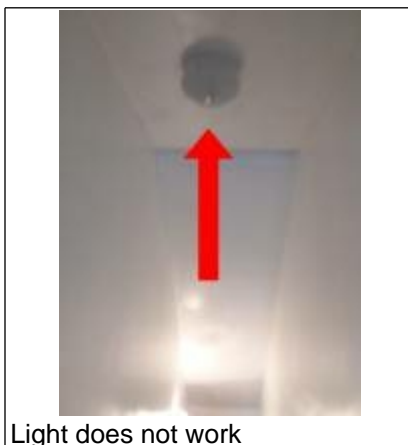
Light does not work

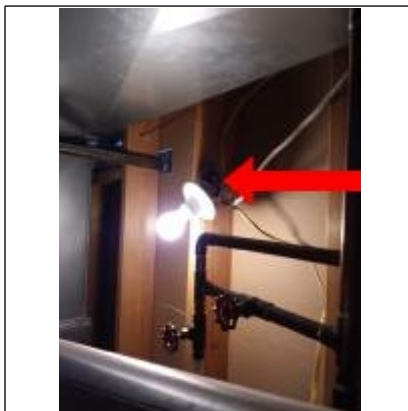
Exposed wiring

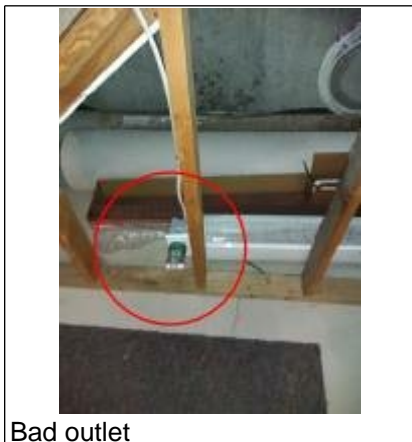
Bad outlet

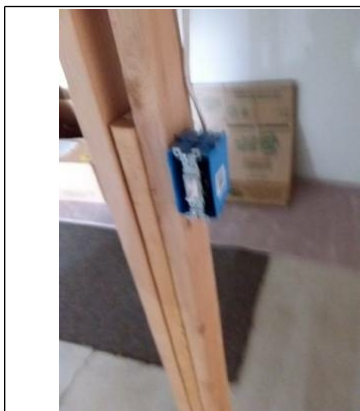
Missing plate cover

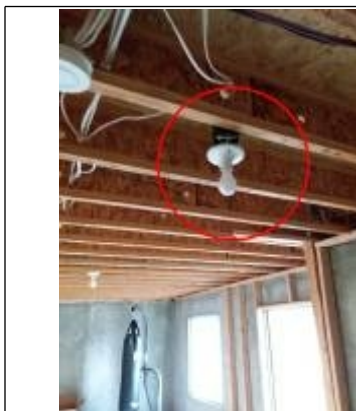
Exposed wires
